## STM32F446xC/xE device errata

This document applies to the part numbers of STM32F446xC/xE devices and the device variants as stated in this page.

It gives a summary and a description of the device errata, with respect to the device datasheet and reference manual RM00390.

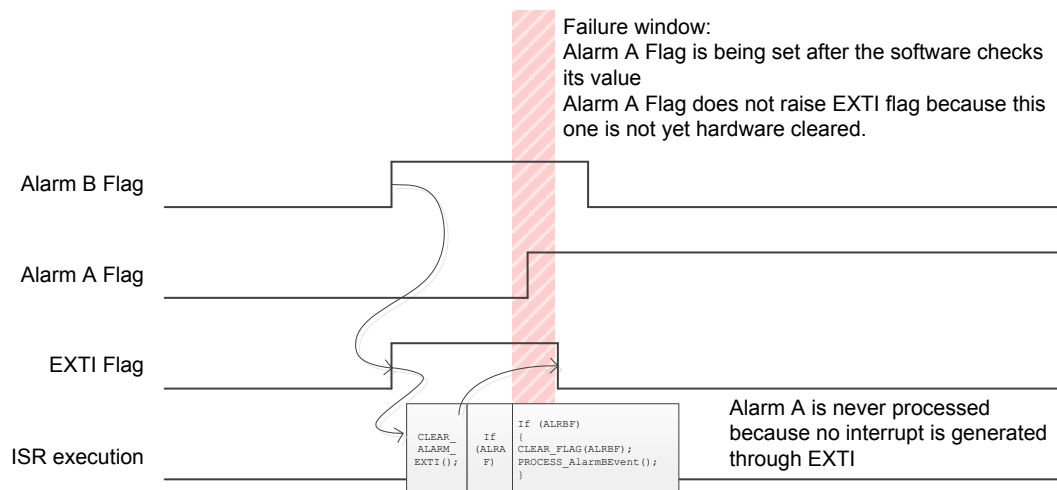
Figure 1. Masked RTC interrupt

The following code example and figure illustrate the failure mechanism: The Alarm A event is lost (fails to generate interrupt) as it occurs in the failure window, that is, after checking the Alarm A event flag but before the effective clear of the EXTI interrupt flag by hardware. The effective clear of the EXTI interrupt flag is delayed with respect to the software instruction to clear it.

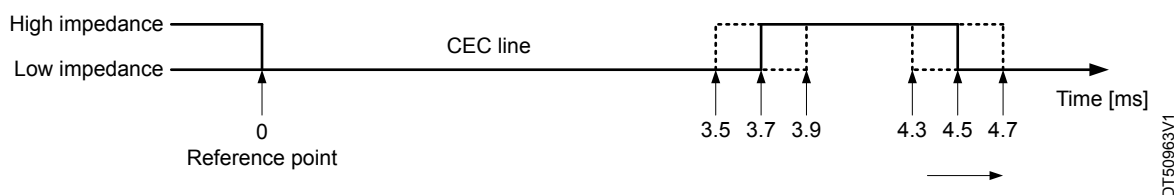
**Figure 2. CEC start bit format with tolerances**

The start bit timing standard tolerances are shown in Figure 2. The start bit is initiated by the device by driving the CEC line low (reference point). After 3.7 ms, the device releases the CEC line and starts checking its level. The following conditions must be met for the start bit to be valid:

If one of these conditions is not met, the transmission is aborted and never automatically retried. No error flag is set and the TXSOM (Tx Start Of Message) bit is not cleared.

The only way to detect this error is for the application software to start a timeout when setting the TXSOM bit, restart it upon ARBLST or any RX event (as the transmission can be delayed by interleaved reception), and stop it upon TXBR (proof that the start bit was transmitted successfully) or TXEND event, or upon any TX error (which clears TXSOM). If the timeout expires (because none of those events occurred), the application software must restart the CEC peripheral and retransmit the message.
