## STM32L031xx/L041xx device errata

### Applicability

This document applies to the part numbers of STM32L031xx/L041xx devices and the device variants as stated in this page. It gives a summary and a description of the device errata, with respect to the device datasheet and reference manual RM0377. Deviation of the real device behavior from the intended device behavior is considered to be a device limitation. Deviation of the description in the reference manual or the datasheet from the intended device behavior is considered to be a documentation erratum. The term “*errata*” applies both to limitations and documentation errata.

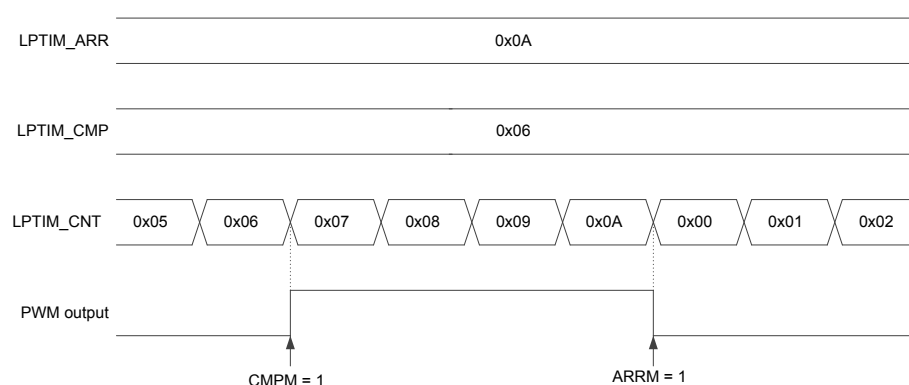
Figure 1. Example of PWM output mode

The following waveform gives the example of PWM output mode and the effect of the delay:

Set the compare value to the desired value minus 1. For instance in order to generate a compare match when `LPTM_CNT = 0x08`, set the compare value to 0x07.
