STM32L011xx/L021xx device errata

Applicability

This document applies to the part numbers of STM32L011xx/L021xx devices and the device variants as stated in this page. It gives a summary and a description of the device errata, with respect to the device datasheet and reference manual RM0377. Deviation of the real device behavior from the intended device behavior is considered to be a device limitation. Deviation of the description in the reference manual or the datasheet from the intended device behavior is considered to be a documentation erratum. The term “*errata*” applies both to limitations and documentation errata.

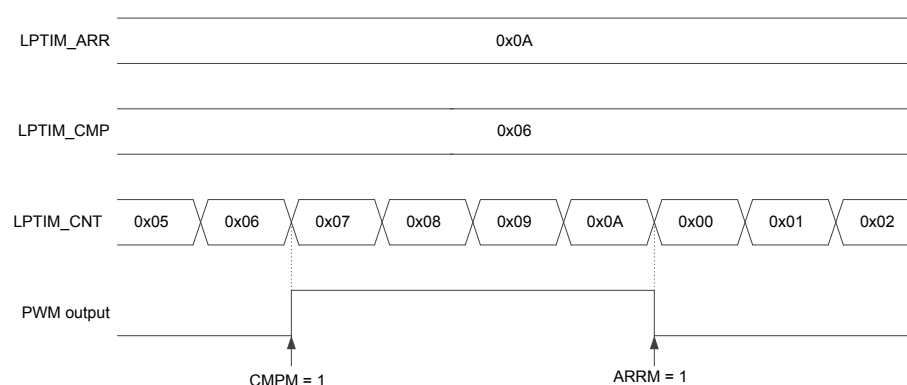
Figure 1. Example of PWM output mode

The following waveform gives the example of PWM output mode and the effect of the delay:

Workaround

Set the compare value to the desired value minus 1. For instance in order to generate a compare match when `LPTIM_CNT = 0x08`, set the compare value to 0x07.

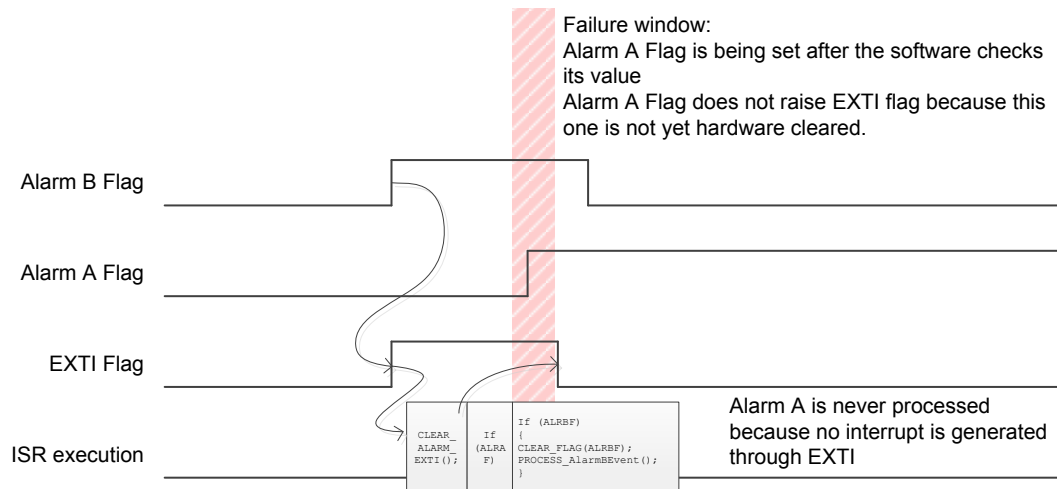
Figure 2. Masked RTC interrupt

The following code example and figure illustrate the failure mechanism: The Alarm A event is lost (fails to generate interrupt) as it occurs in the failure window, that is, after checking the Alarm A event flag but before the effective clear of the EXTI interrupt flag by hardware. The effective clear of the EXTI interrupt flag is delayed with respect to the software instruction to clear it.
