STM32L496xx/4A6xx device errata

This document applies to the part numbers of STM32L496xx/4A6xx devices and the device variants as stated in this page. It gives a summary and a description of the device errata, with respect to the device datasheet and reference manual RM351. Deviation of the real device behavior from the intended device behavior is considered to be a device limitation. Deviation of the description in the reference manual or the datasheet from the intended device behavior is considered to be a documentation erratum. The term “*errata*” applies both to limitations and documentation errata.

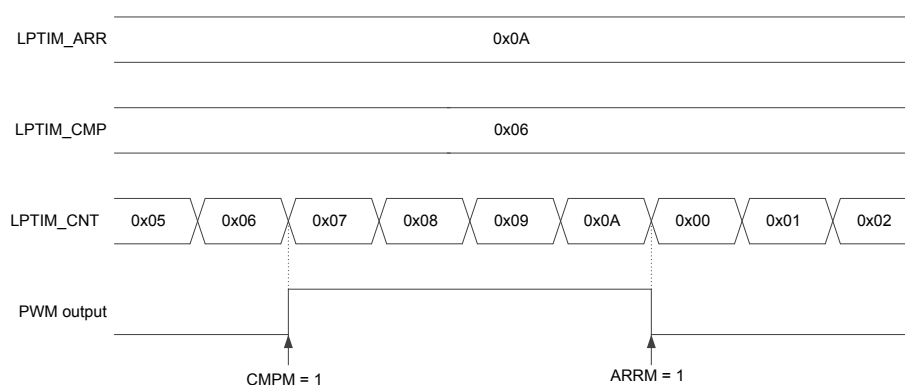
Figure 1. Example of PWM output mode

The following waveform gives the example of PWM output mode and the effect of the delay:

Set the compare value to the desired value minus 1. For instance in order to generate a compare match when LPTIM_CNT = 0x08, set the compare value to 0x07.

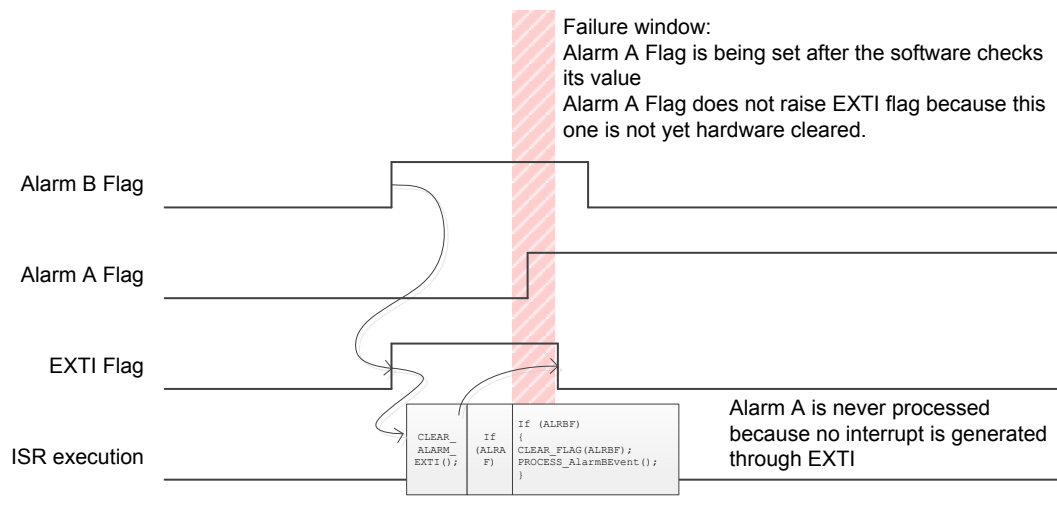
Figure 2. Masked RTC interrupt

The following code example and figure illustrate the failure mechanism: The Alarm A event is lost (fails to generate interrupt) as it occurs in the failure window, that is, after checking the Alarm A event flag but before the effective clear of the EXTI interrupt flag by hardware. The effective clear of the EXTI interrupt flag is delayed with respect to the software instruction to clear it.
