STM32H742xI/G, STM32H743xI/G STM32H750xB, STM32H753xI

Errata sheet

STM32H742xI/G, STM32H743xI/G, STM32H750xB, STM32H753xI device errata

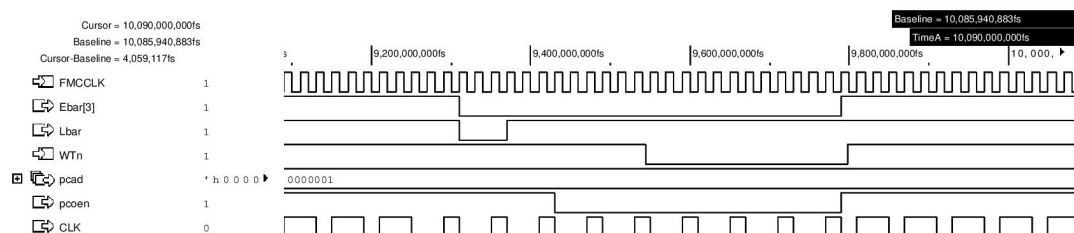
Figure 1. RTL simulation timing diagram

With a clock division of 3 (CLKDIV = 0x02), the FMC continuous clock duty cycle, which is 2/3 high and 1/3 low during read or write transfers, changes to 1/3 high and 2/3 low on the first clock after transfer. The duty cycle change creates a narrow pulse after the data transfer, as illustrated by Figure 1 below.

The narrow pulse after a data transfer is not expected to cause a timing violation for PSRAM, as CLK may be off and irrelevant after the transfer is complete.

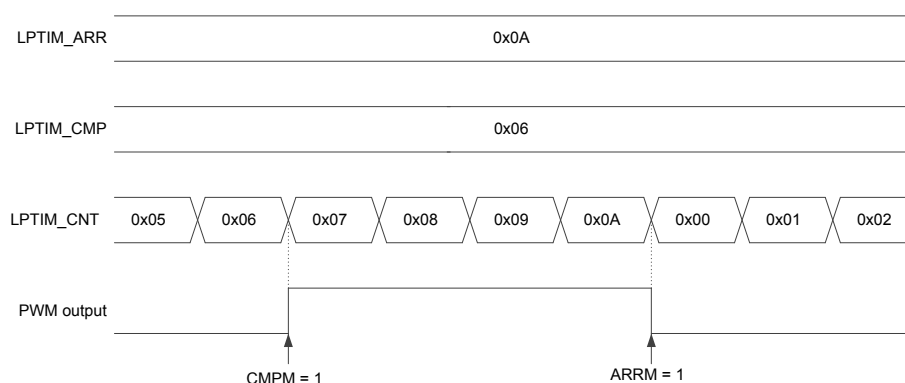
Figure 2. Example of PWM output mode

The following waveform gives the example of PWM output mode and the effect of the delay:

Set the compare value to the desired value minus 1. For instance in order to generate a compare match when LPTM_CNT = 0x08, set the compare value to 0x07.

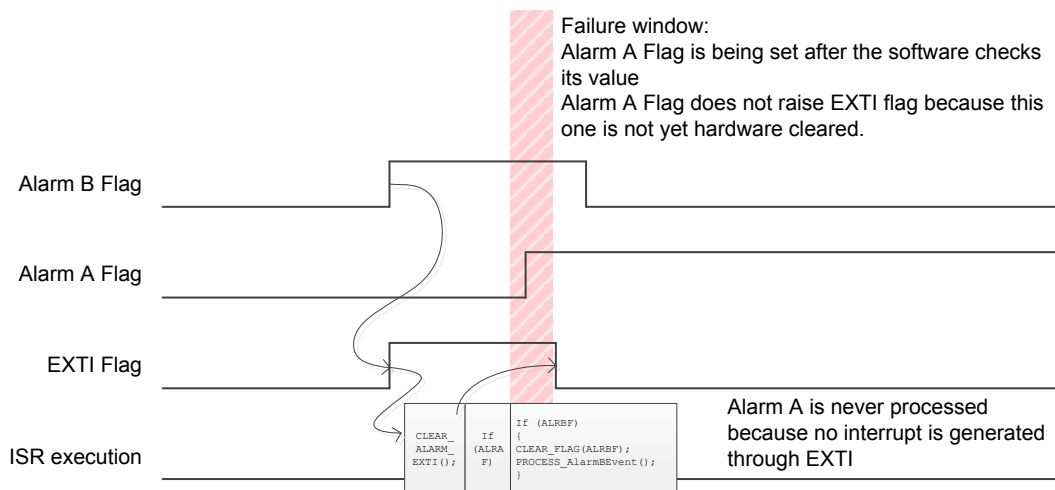
Figure 3. Masked RTC interrupt

The following code example and figure illustrate the failure mechanism: The Alarm A event is lost (fails to generate interrupt) as it occurs in the failure window, that is, after checking the Alarm A event flag but before the effective clear of the EXTI interrupt flag by hardware. The effective clear of the EXTI interrupt flag is delayed with respect to the software instruction to clear it.

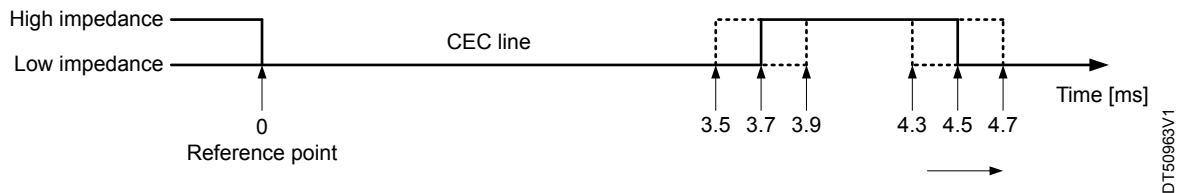
Figure 4. CEC start bit format with tolerances

If one of these conditions is not met, the transmission is aborted and never automatically retried. No error flag is set and the TXSOM (Tx Start Of Message) bit is not cleared.

The only way to detect this error is for the application software to start a timeout when setting the TXSOM bit, restart it upon ARBLST or any RX event (as the transmission can be delayed by interleaved reception), and stop it upon TXBR (proof that the start bit was transmitted successfully) or TXEND event, or upon any TX error (which clears TXSOM). If the timeout expires (because none of those events occurred), the application software must restart the CEC peripheral and retransmit the message.
