STM32WB55xx/STM32WB35Cx device errata

This document applies to the part numbers of STM32WB55xx/STM32WB35Cx devices and the device variants as stated in this page.

It gives a summary and a description of the device errata, with respect to the device datasheet and reference manual RM0434. Deviation of the real device behavior from the intended device behavior is considered to be a device limitation. Deviation of the description in the reference manual or the datasheet from the intended device behavior is considered to be a documentation erratum. The term “*errata*” applies both to limitations and documentation errata.

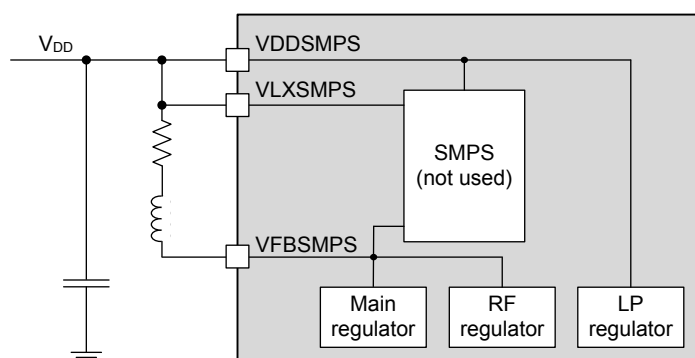
Figure 1. Workaround

The Hard Fault can be observed in case SYSCLK=HSE. Otherwise the risk is radio malfunction since clocked from HSE directly too.

The recommended inductor characteristics are the inductance 1.8 nH +/- 0.1 nH, self-resonance frequency of 6 Ghz +/-15 %, and rated current of 1000 mA. The resistor of 2.2 Ω recommended resistance must be dimensioned to dissipate 1 watt during 5 ns. Refer to Minimal BOM for STM32WB Series microcontrollers (AN5290) for more details.

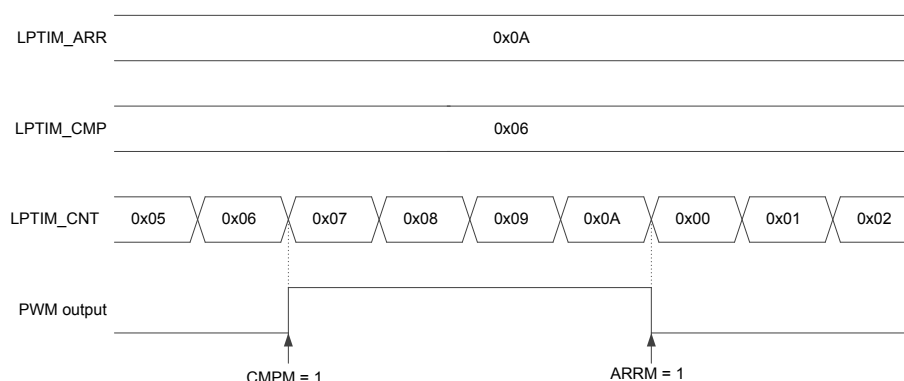
Figure 2. Example of PWM output mode

The following waveform gives the example of PWM output mode and the effect of the delay:

Set the compare value to the desired value minus 1. For instance in order to generate a compare match when LPTM_CNT = 0x08, set the compare value to 0x07.

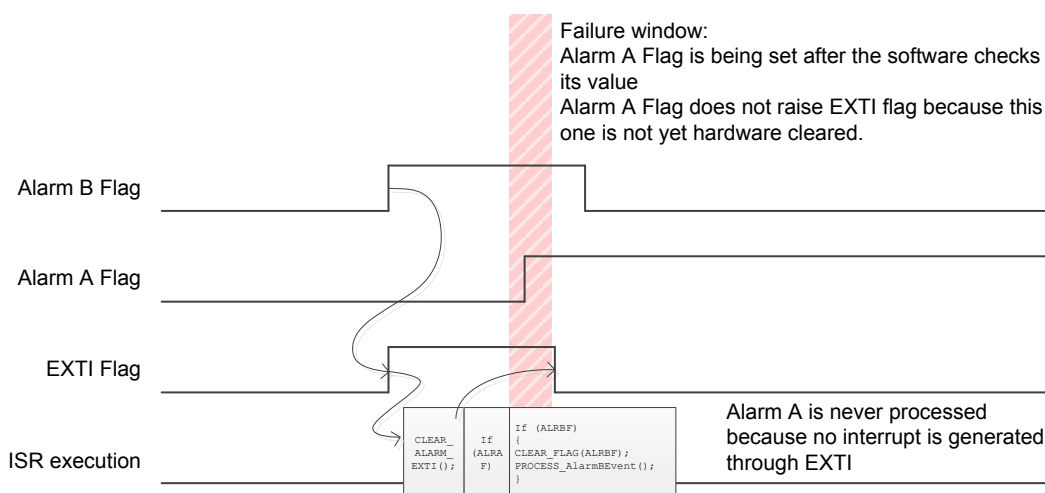
Figure 3. Masked RTC interrupt

The following code example and figure illustrate the failure mechanism: The Alarm A event is lost (fails to generate interrupt) as it occurs in the failure window, that is, after checking the Alarm A event flag but before the effective clear of the EXTI interrupt flag by hardware. The effective clear of the EXTI interrupt flag is delayed with respect to the software instruction to clear it.
