The BlueNRG-2 device limitations

Silicon identification

This errata sheet applies to the following STMicroelectronics BlueNRG-2 devices:

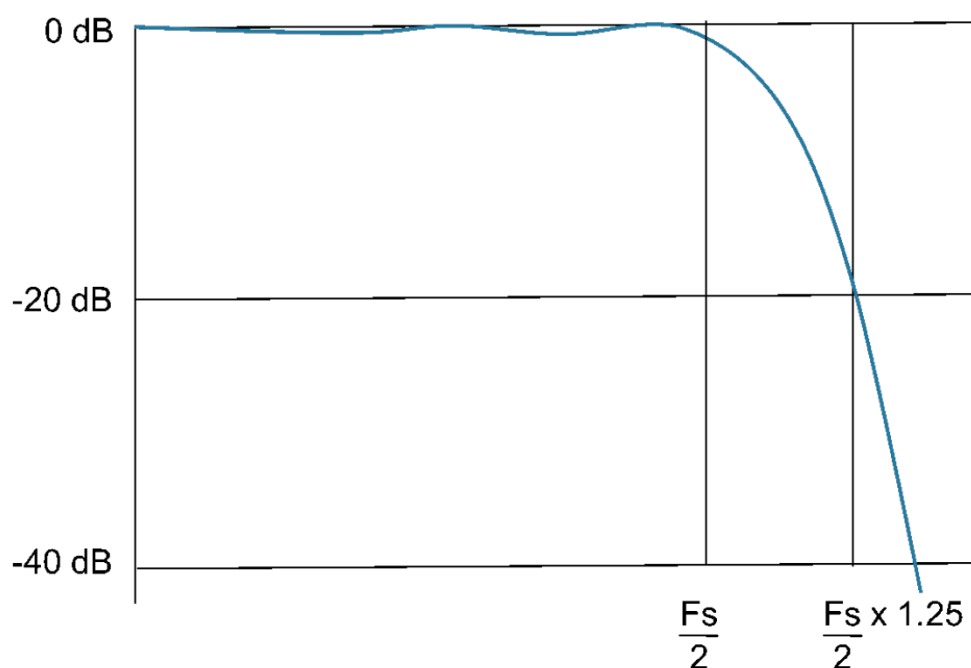
Figure 1. Interpolation filter frequency response

Description: the bandwidth of the anti-aliasing filter is slightly broader with respect to the signal bandwidth, potentially thus generating unwanted aliased signal after the decimation filter.

Impact: When a pure sine wave, generated in the $[F_s/2; 1.25 \cdot F_s/2]$ range, is being sampled, user can notice an attenuated aliased sine wave in the $[0.75 \cdot F_s/2; F_s/2]$ range.

In case of waveform acquisition, especially when audio speech and music is caught, no further degradation has been identified.

F_s is the sampling frequency on the output of the downsampling filter, described as ADC data rate in the datasheet.

Workaround: by choosing an appropriate oversampling factor (OSR), so that maximum frequency of the sampled signal is lower than $F_s/2$, aliasing may be avoided.
