STM32MP151x/3x/7x device errata

This document applies to the part numbers of STM32MP151x/3x/7x devices and the device variants as stated in this page. It gives a summary and a description of the device errata, with respect to the device datasheet and reference manual RM0441 for STM32MP151x, RM0442 for STM32MP153x, and RM0436 for STM32MP157x.

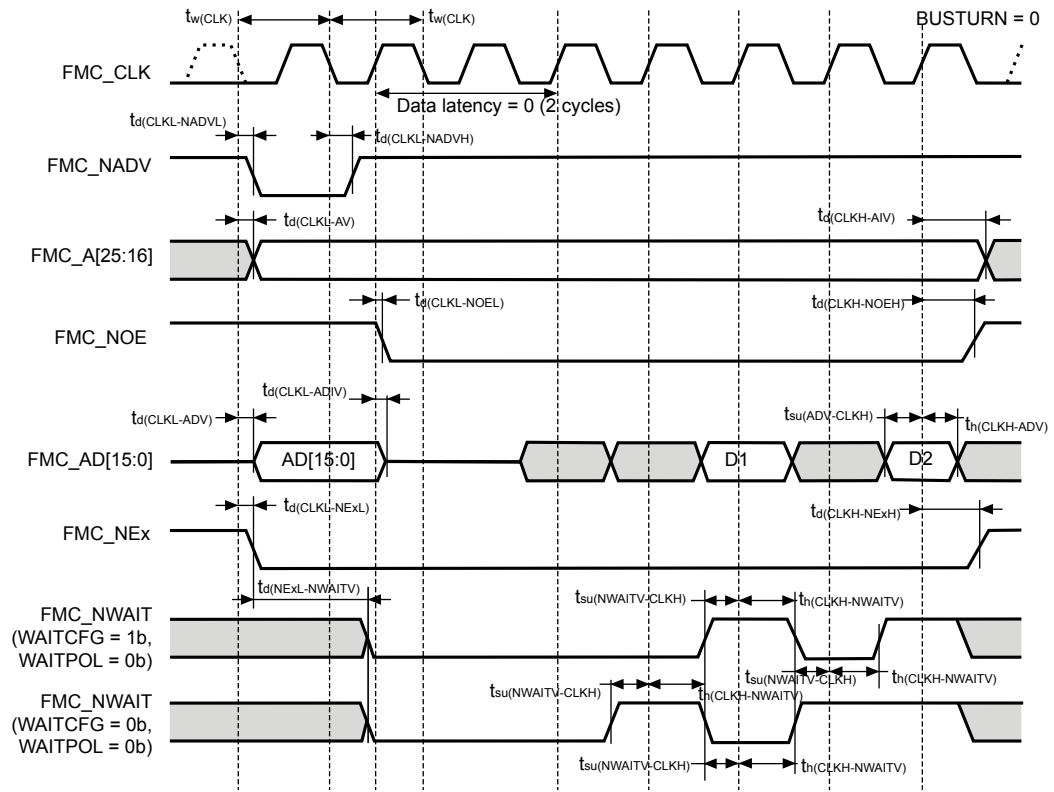
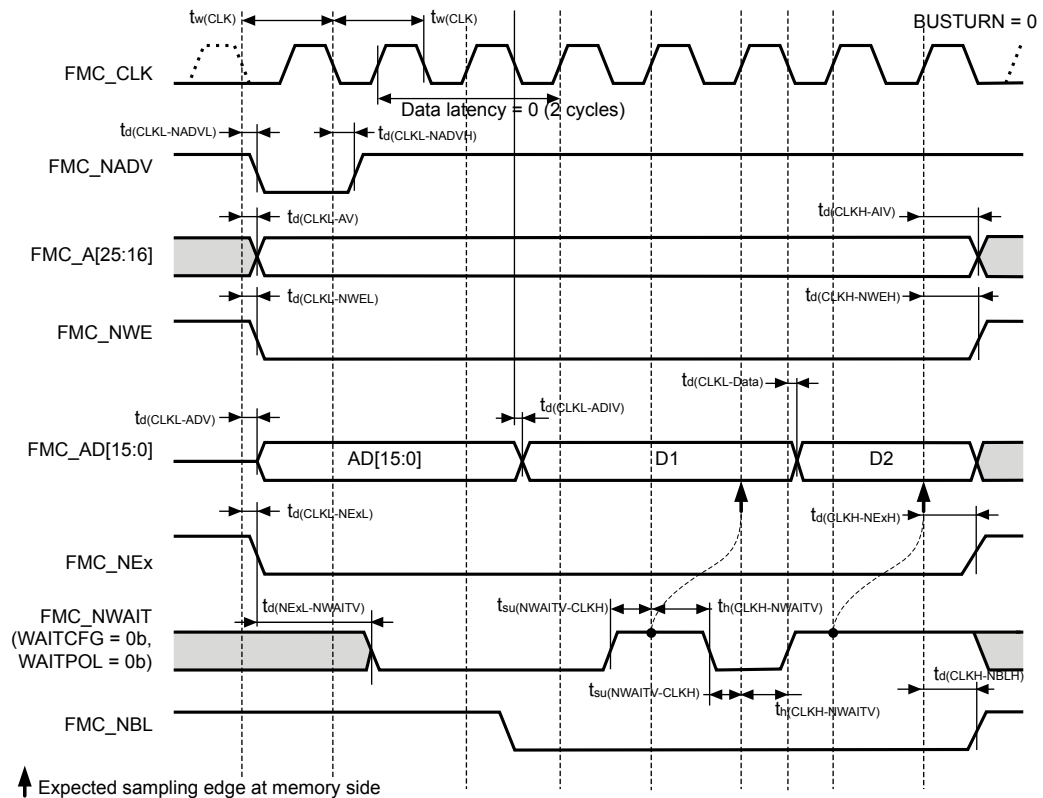
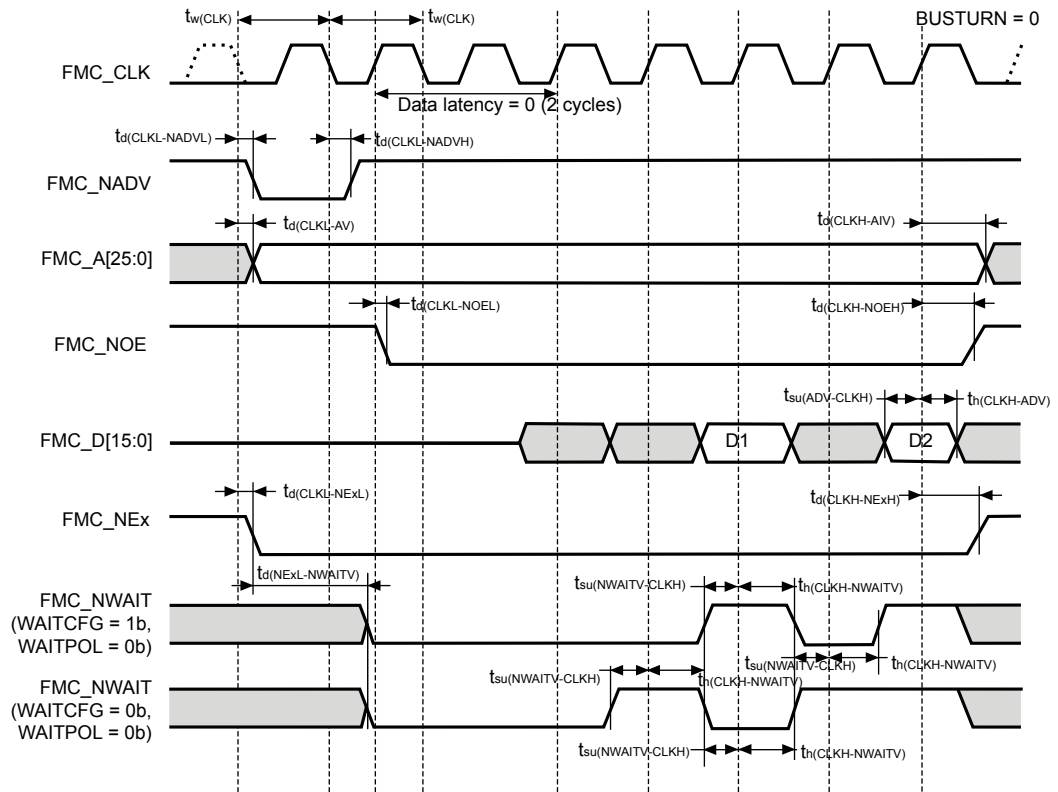
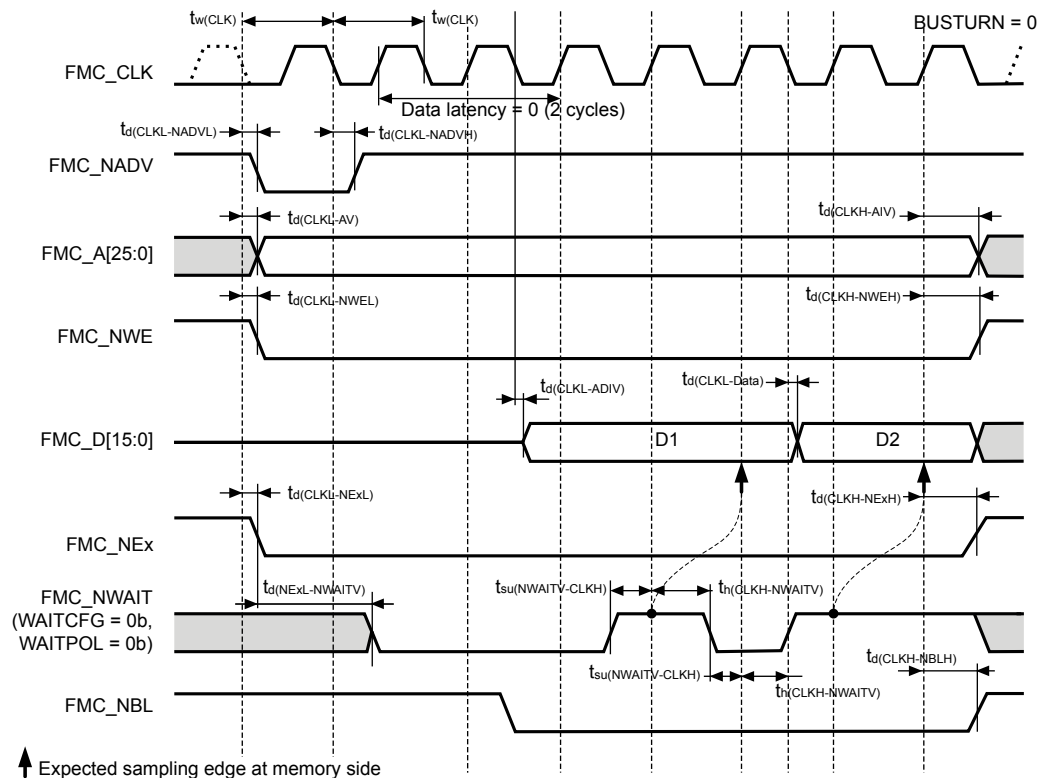
FMC_NWAIT input should be active before a specific timing delay (with respect to FMC_NE falling edge) to be considered by the FMC sequencer for correct wait state(s) insertion above the fixed DATLAT setting. This delay value is missing in the product datasheet.

The following figures should be used for released datasheets where the $t_{d(NEXL-NWAITV)}$ is not present.

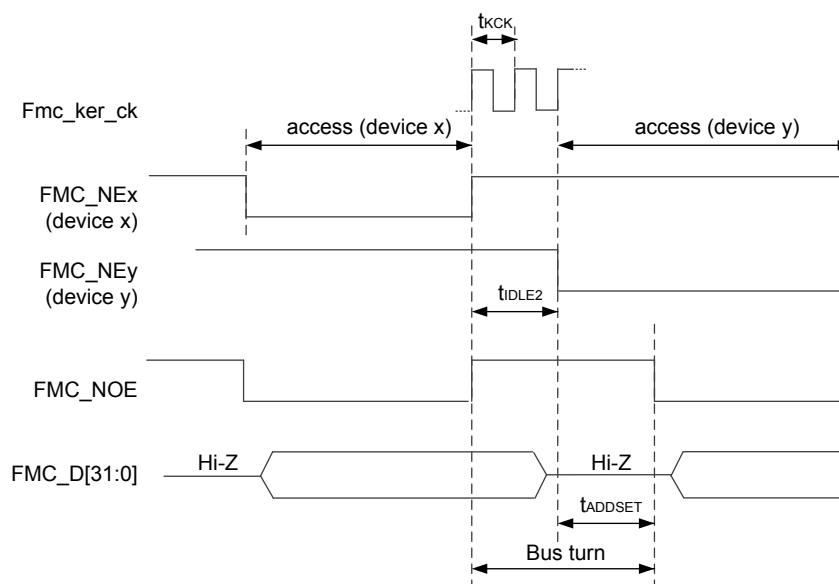
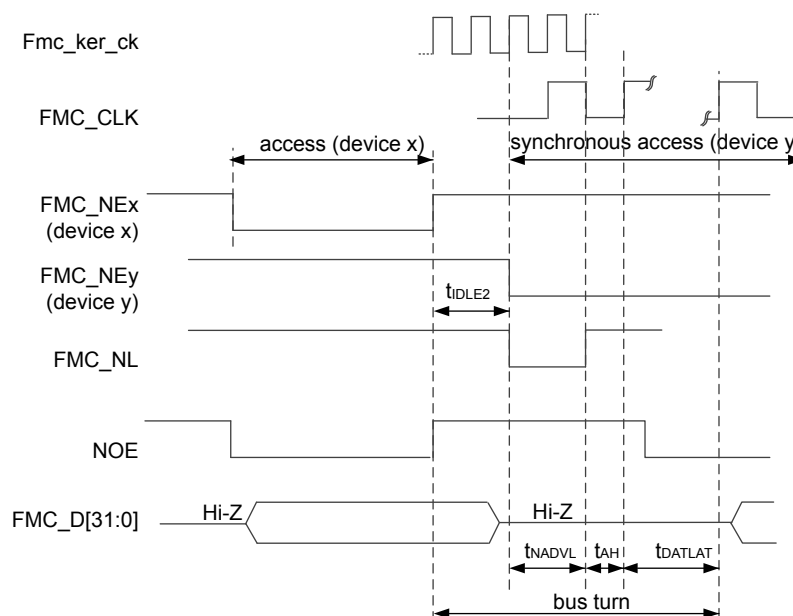
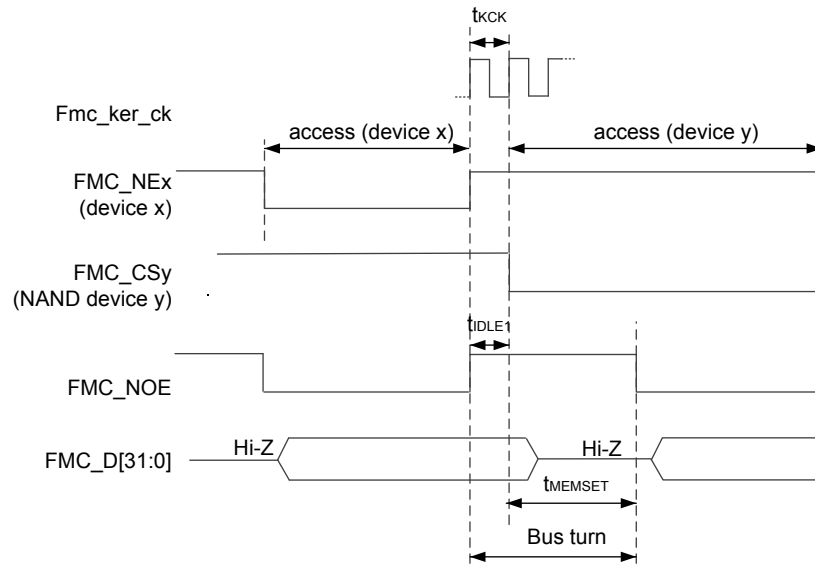
1. Two consecutive accesses to non-multiplexed NOR/PSRAM devices:
Program t_{ADSET} (NOR/PSRAM address setup phase) as needed (see [Figure 5](#)).
2. Access to a non-multiplexed NOR/PSRAM followed by an access either to a NOR/PSRAM device with multiplexed A/DQ signals or to a synchronous device:
Decrease the FMC kernel clock frequency in order to meet the timing constraints (see [Figure 6](#)).
3. Access to a non-multiplexed NOR/PSRAM followed by an access to a NAND flash memory device
Program t_{MEMSET} (NOR/PSRAM address setup phase) as needed (see [Figure 7](#)).

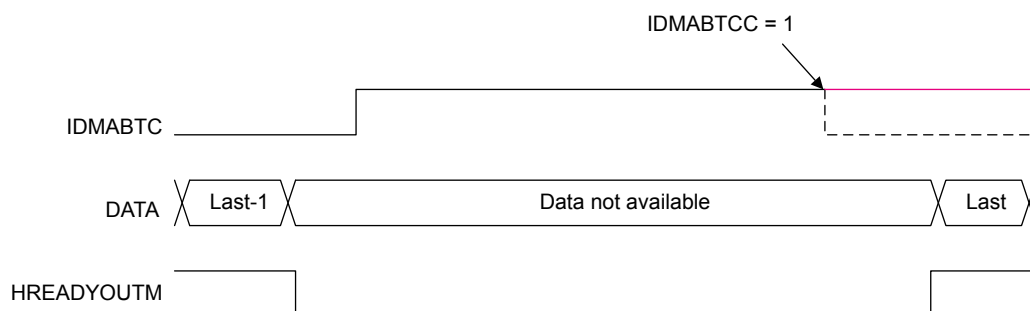
Figure 8. SDMMC AHB transfer vs IDMABTC flag status

If the internal/external memory is not ready to transmit/receive the last word before the IDMABTCC is set, the IDMABTC flag is not cleared whereas it should be (see Figure 8). As a result, the software may consider it several times.

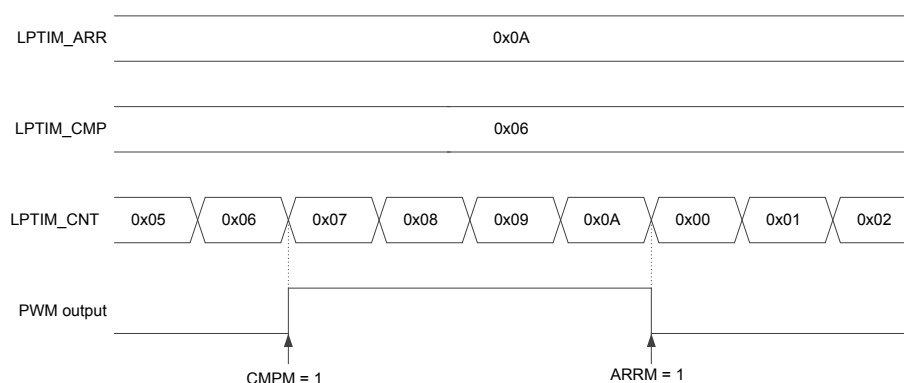
Figure 9. Example of PWM output mode

The following waveform gives the example of PWM output mode and the effect of the delay:

Set the compare value to the desired value minus 1. For instance in order to generate a compare match when LPTM_CNT = 0x08, set the compare value to 0x07.
