STM32H745xI/G, STM32H755xI, STM32H747xI/G, STM32H757xI device errata

This document applies to the part numbers of STM32H745xI/G, STM32H755xI, STM32H747xI/G, STM32H757xI devices and the device variants as stated in this page.

It gives a summary and a description of the device errata, with respect to the device datasheet and reference manual RM0399. Deviation of the real device behavior from the intended device behavior is considered to be a device limitation. Deviation of the description in the reference manual or the datasheet from the intended device behavior is considered to be a documentation erratum. The term “*errata*” applies both to limitations and documentation errata.

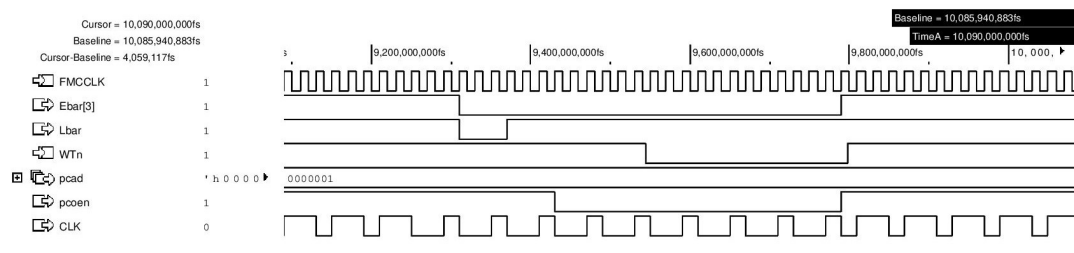
Figure 1. RTL simulation timing diagram

With a clock division of 3 (CLKDIV = 0x02), the FMC continuous clock duty cycle, which is 2/3 high and 1/3 low during read or write transfers, changes to 1/3 high and 2/3 low on the first clock after transfer. The duty cycle change creates a narrow pulse after the data transfer, as illustrated by [Figure 1](#) below.

The narrow pulse after a data transfer is not expected to cause a timing violation for PSRAM, as CLK may be off and irrelevant after the transfer is complete.

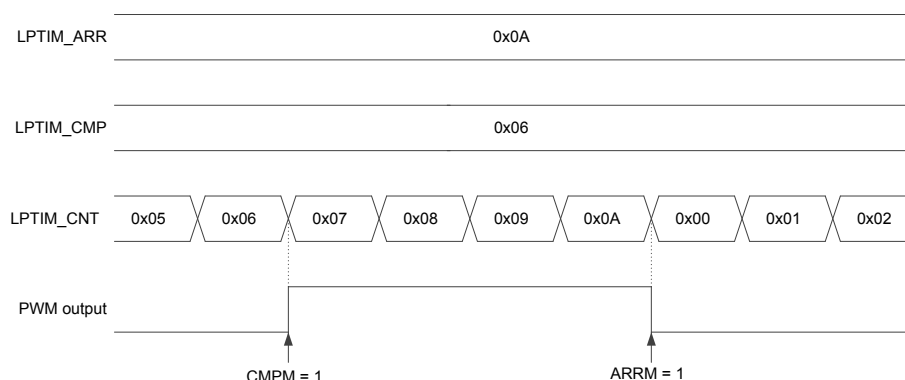
Figure 2. Example of PWM output mode

The following waveform gives the example of PWM output mode and the effect of the delay:

Set the compare value to the desired value minus 1. For instance in order to generate a compare match when LPTM_CNT = 0x08, set the compare value to 0x07.

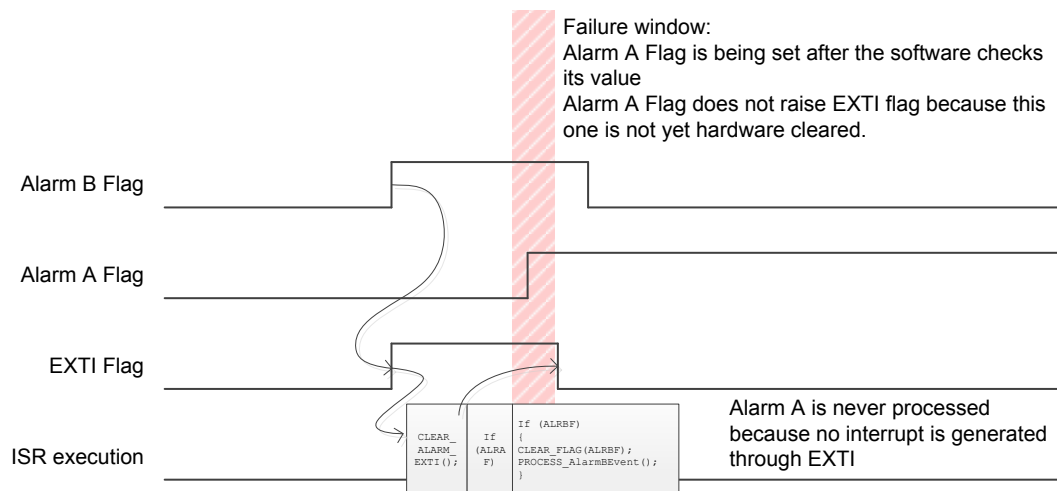
Figure 3. Masked RTC interrupt

The following code example and figure illustrate the failure mechanism: The Alarm A event is lost (fails to generate interrupt) as it occurs in the failure window, that is, after checking the Alarm A event flag but before the effective clear of the EXTI interrupt flag by hardware. The effective clear of the EXTI interrupt flag is delayed with respect to the software instruction to clear it.
