STM32L552xx/562xx device errata

Applicability

This document applies to the part numbers of STM32L552xx/562xx devices and the device variants as stated in this page. It gives a summary and a description of the device errata, with respect to the device datasheet and reference manual RM438. Deviation of the real device behavior from the intended device behavior is considered to be a device limitation. Deviation of the description in the reference manual or the datasheet from the intended device behavior is considered to be a documentation erratum. The term “*errata*” applies both to limitations and documentation errata.

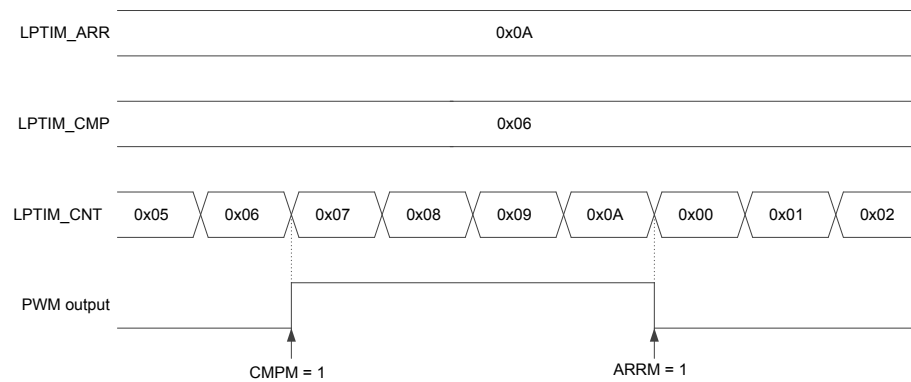
Figure 1. Example of PWM output mode

The following waveform gives the example of PWM output mode and the effect of the delay:

Set the compare value to the desired value minus 1. For instance in order to generate a compare match when LPTIM_CNT = 0x08, set the compare value to 0x07.
