The BlueNRG-1 device limitations

Silicon identification

This errata sheet applies to the following STMicroelectronics BlueNRG-1 devices:

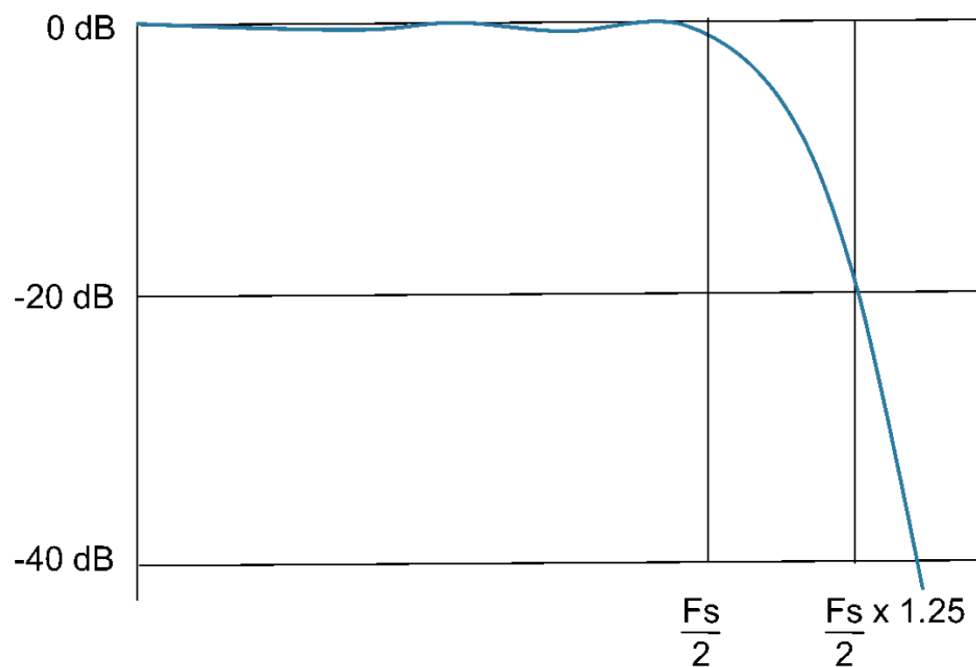
Figure 1. Interpolation filter frequency response

1.8 ADC unwanted aliased signal after the decimation filter

Description: the bandwidth of the anti-aliasing filter is slightly broader with respect to the signal bandwidth, potentially thus generating unwanted aliased signal after the decimation filter.

Impact: When a pure sine wave, generated in the $[F_s/2; 1.25 \cdot F_s/2]$ range, is being sampled, user can notice an attenuated aliased sine wave in the $[0.75 \cdot F_s/2; F_s/2]$ range.

In case of waveform acquisition, especially when audio speech and music is caught, no further degradation has been identified.

F_s is the sampling frequency on the output of the downsampling filter, described as ADC data rate in the datasheet.

Workaround: by choosing an appropriate oversampling factor (OSR), so that maximum frequency of the sampled signal is lower than $F_s/2$, aliasing may be avoided.
