### STM32L010xx device errata

This document applies to the part numbers of STM32L010xx devices and the device variants as stated in this page.

It gives a summary and a description of the device errata, with respect to the device datasheet and reference manual RM0451.

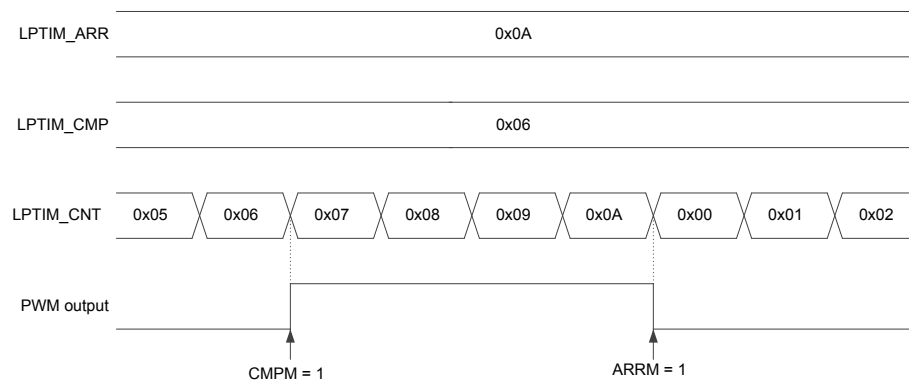
**Figure 1. Example of PWM output mode**

The following waveform gives the example of PWM output mode and the effect of the delay:

Set the compare value to the desired value minus 1. For instance in order to generate a compare match when LPTM\_CNT = 0x08, set the compare value to 0x07.

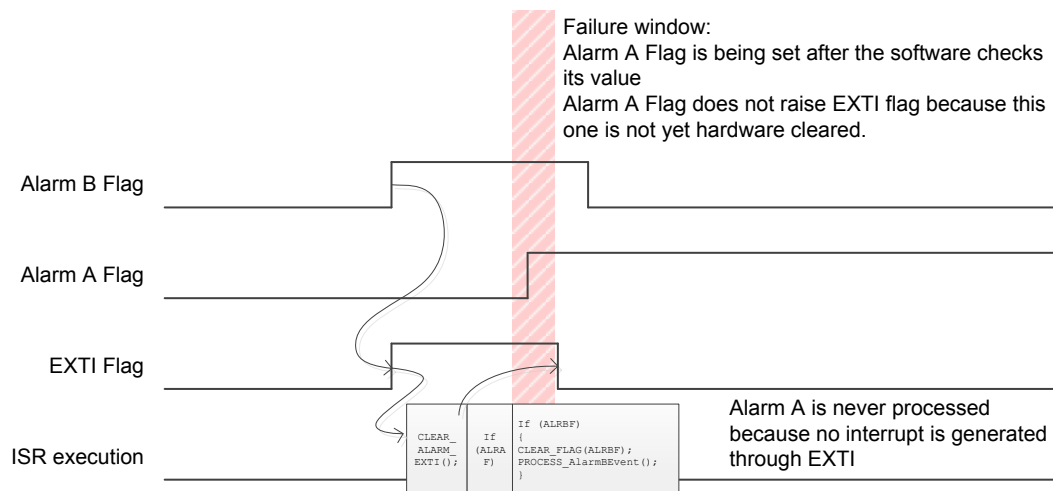
Figure 2. Masked RTC interrupt

The following code example and figure illustrate the failure mechanism: The Alarm A event is lost (fails to generate interrupt) as it occurs in the failure window, that is, after checking the Alarm A event flag but before the effective clear of the EXTI interrupt flag by hardware. The effective clear of the EXTI interrupt flag is delayed with respect to the software instruction to clear it.
