STM32H72xx/73xx device errata

Applicability

This document applies to the part numbers of STM32H72xx/73xx devices and the device variants as stated in this page. It gives a summary and a description of the device errata, with respect to the device datasheet and reference manual RM0468. Deviation of the real device behavior from the intended device behavior is considered to be a device limitation. Deviation of the description in the reference manual or the datasheet from the intended device behavior is considered to be a documentation erratum. The term “*errata*” applies both to limitations and documentation errata.

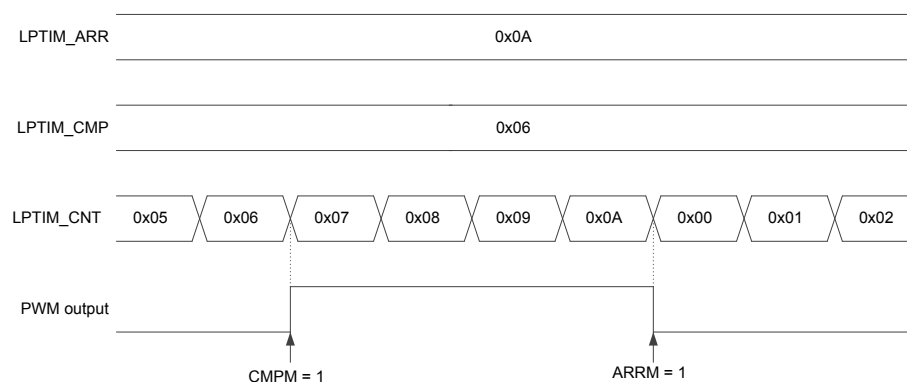
Figure 1. Example of PWM output mode

The following waveform gives the example of PWM output mode and the effect of the delay:

Set the compare value to the desired value minus 1. For instance in order to generate a compare match when LPTM_CNT = 0x08, set the compare value to 0x07.

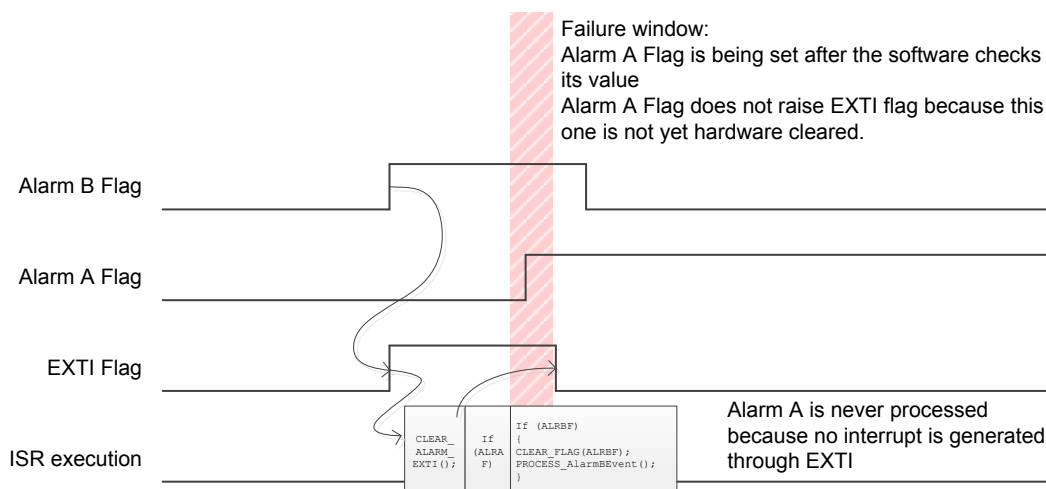
Figure 2. Masked RTC interrupt

The following code example and figure illustrate the failure mechanism: The Alarm A event is lost (fails to generate interrupt) as it occurs in the failure window, that is, after checking the Alarm A event flag but before the effective clear of the EXTI interrupt flag by hardware. The effective clear of the EXTI interrupt flag is delayed with respect to the software instruction to clear it.
