## STM32WB50CG/30CE device errata

This document applies to STM32WB50CG/30CE devices and the device variants as stated in this page.

It gives a summary and a description of the device errata, with respect to the device datasheet and reference manual RM0471.

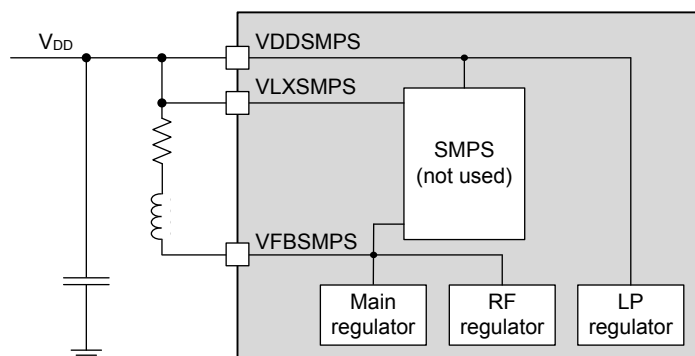
**Figure 1. Workaround**

The Hard Fault can be observed in case SYSCLK=HSE. Otherwise the risk is radio malfunction since clocked from HSE directly too.

The recommended inductor characteristics are the inductance 1.8 nH +/- 0.1 nH, self-resonance frequency of 6 GHz +/-15 %, and rated current of 1000 mA. The resistor of 2.2  $\Omega$  recommended resistance must be dimensioned to dissipate 1 watt during 5 ns. Refer to Minimal BOM for STM32WB Series microcontrollers (AN5290) for more details.

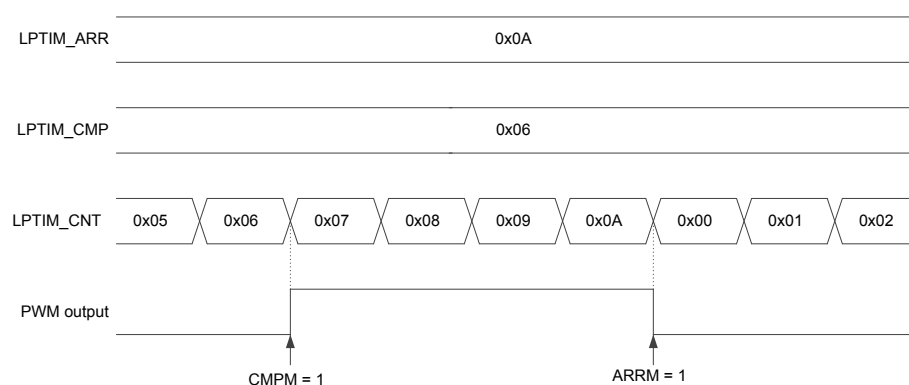
**Figure 2. Example of PWM output mode**

The following waveform gives the example of PWM output mode and the effect of the delay:

Set the compare value to the desired value minus 1. For instance in order to generate a compare match when `LPTM_CNT = 0x08`, set the compare value to 0x07.
