## STM32G491xx/4A1xx device errata

### Applicability

This document applies to the part numbers of STM32G491xx/4A1xx devices and the device variants as stated in this page. It gives a summary and a description of the device errata, with respect to the device datasheet and reference manual RM0440. Deviation of the real device behavior from the intended device behavior is considered to be a device limitation. Deviation of the description in the reference manual or the datasheet from the intended device behavior is considered to be a documentation erratum. The term “*errata*” applies both to limitations and documentation errata.

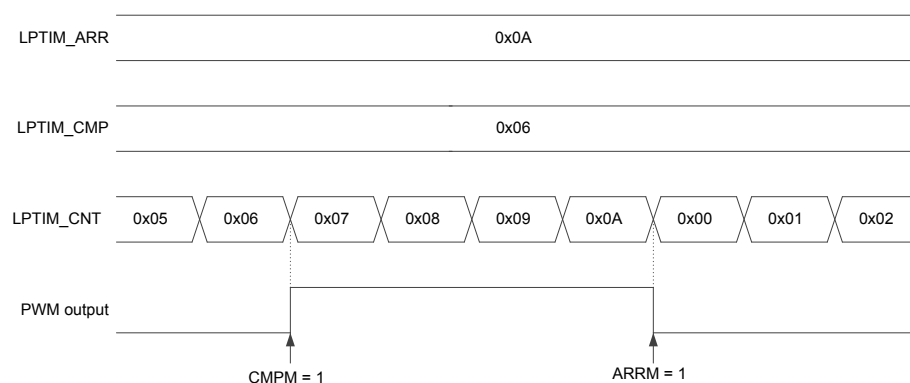
**Figure 1. Example of PWM output mode**

The following waveform gives the example of PWM output mode and the effect of the delay:

Set the compare value to the desired value minus 1. For instance in order to generate a compare match when LPTIM\_CNT = 0x08, set the compare value to 0x07.
