## STM32MP131x/3x/5x device errata

This document applies to the part numbers of STM32MP131x/3x/5x devices and the device variants as stated in this page. It gives a summary and a description of the device errata, with respect to the device datasheet and reference manual RM0475. Deviation of the real device behavior from the intended device behavior is considered to be a device limitation. Deviation of the description in the reference manual or the datasheet from the intended device behavior is considered to be a documentation erratum. The term “errata” applies both to limitations and documentation errata.

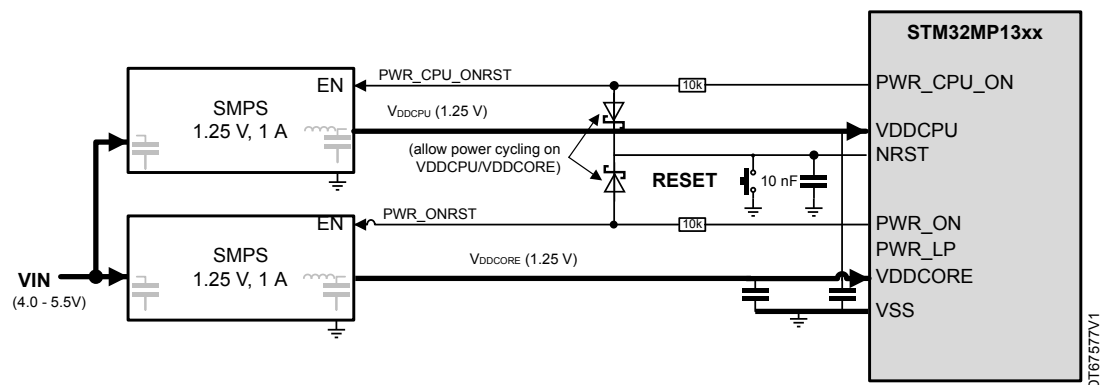
**Figure 1. External SMPS connection**

Activating NRST then causes the  $V_{DDCPU}$  and  $V_{DDCORE}$  supply voltages to cycle.

The drawback is that, the debug logic also being reset, it is not possible to debug the boot chain (TF-A and U-Boot) as any breakpoints set are lost during the power cycle.

1. **By hardware**, ensure that the  $V_{DDCORE}$  and  $V_{DDCPU}$  logic is reset on NRST activation:
  - With STPMIC1  
By default, a power cycle on  $V_{DDCORE}$  and  $V_{DDCPU}$  (and  $V_{DD}$ ) occurs upon activating NRST.
  - Without STPMIC1  
Connect the POWER\_CPU\_ON and PWR\_ON signals to the external SMPS enable inputs as illustrated next.

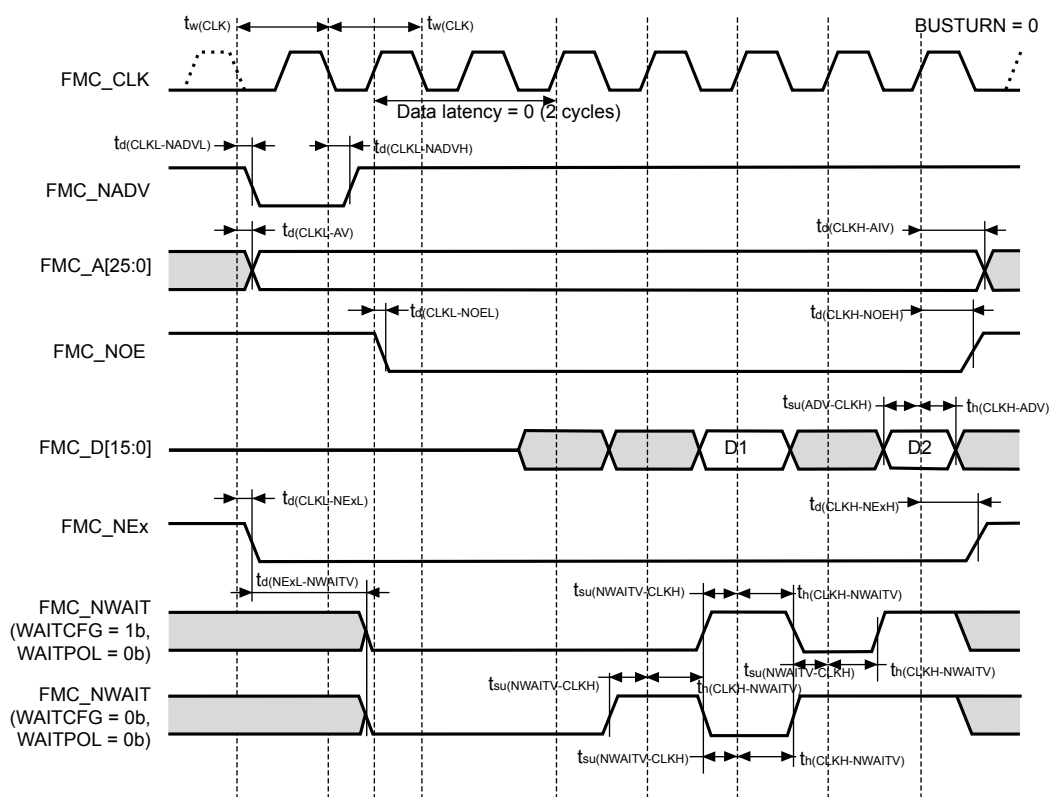
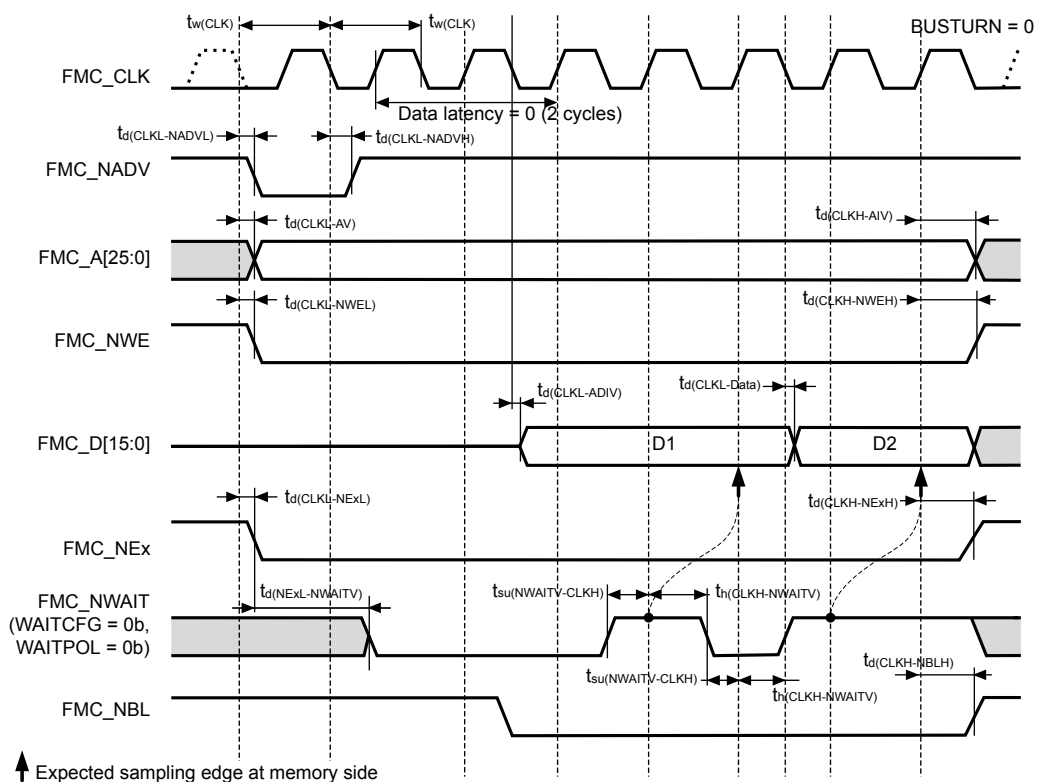
FMC\_NWAIT input should be active before a specific timing delay (with respect to FMC\_NE falling edge) to be considered by the FMC sequencer for correct wait state(s) insertion above the fixed DATLAT setting. This delay value is missing in the product datasheet.

The following figures should be used for released datasheets where the  $t_{d(NEXL-NWAITV)}$  is not present.

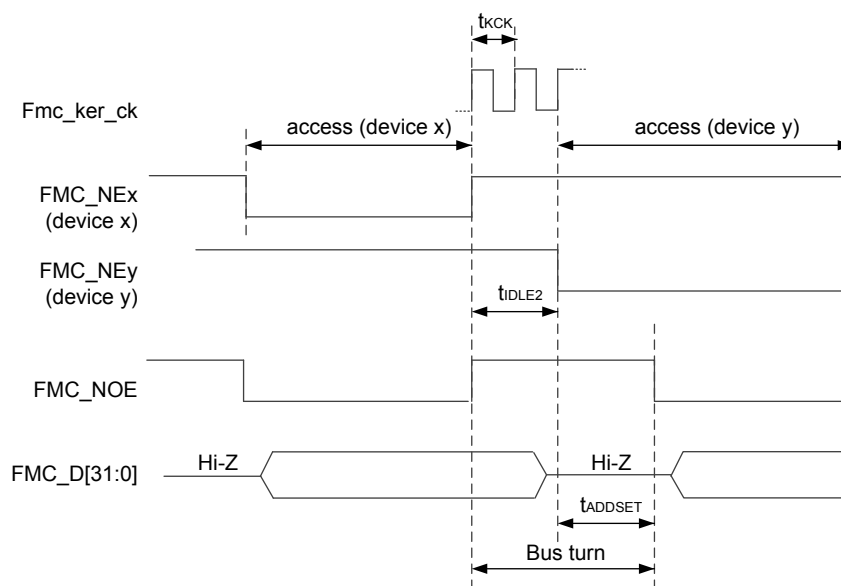
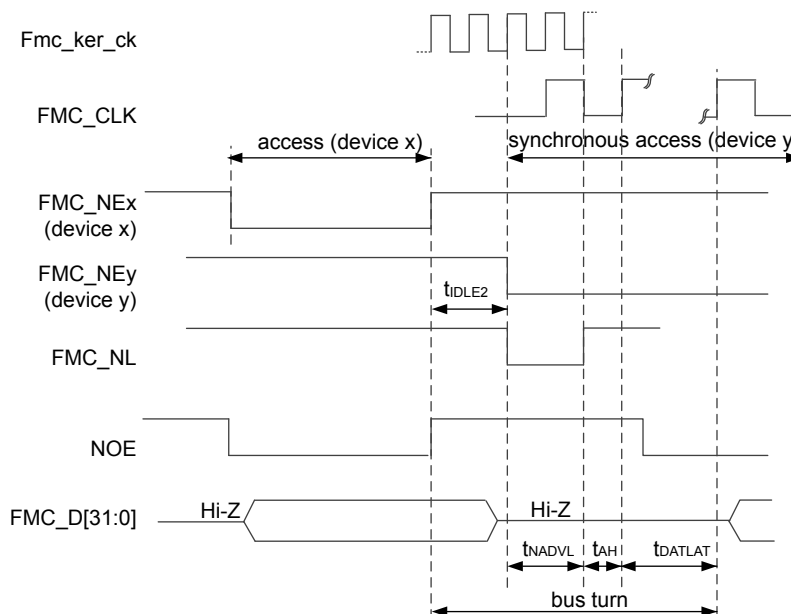
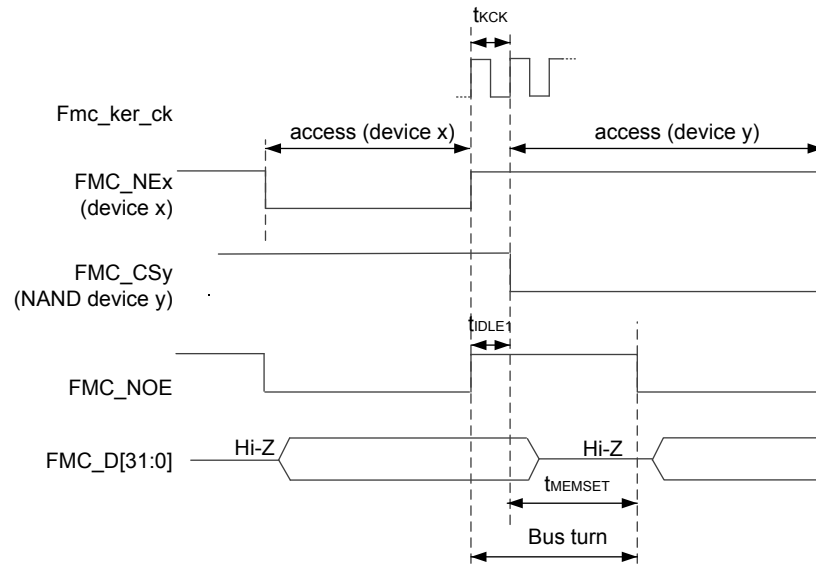
Table 6 gives the internal latencies that are not mentioned in the product datasheets. Refer to the datasheets for more details about the others timing values.

1. Two consecutive accesses to non-multiplexed NOR/PSRAM devices:  
Program  $t_{ADSET}$  (NOR/PSRAM address setup phase) as needed (see [Figure 6](#)).
2. Access to a non-multiplexed NOR/PSRAM followed by an access either to a NOR/PSRAM device with multiplexed A/DQ signals or to a synchronous device:  
Decrease the FMC kernel clock frequency in order to meet the timing constraints (see [Figure 7](#)).
3. Access to a non-multiplexed NOR/PSRAM followed by an access to a NAND flash memory device  
Program  $t_{MEMSET}$  (NOR/PSRAM address setup phase) as needed (see [Figure 8](#)).

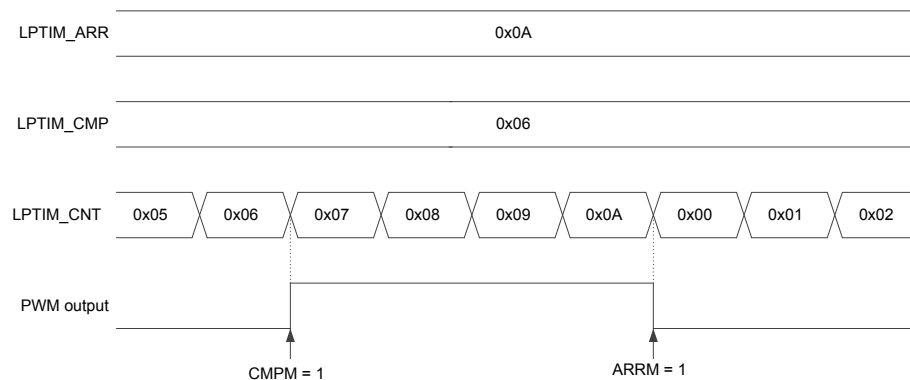
**Figure 9. Example of PWM output mode**

The following waveform gives the example of PWM output mode and the effect of the delay:

Set the compare value to the desired value minus 1. For instance in order to generate a compare match when LPTIM\_CNT = 0x08, set the compare value to 0x07.
