STM32WB10CC device errata

This document applies to STM32WB10CC devices and the device variants as stated in this page.

It gives a summary and a description of the device errata, with respect to the device datasheet and reference manual RM0478.

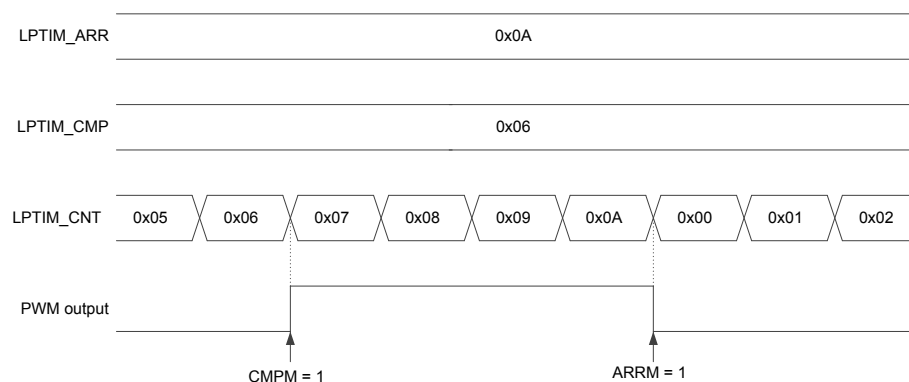
Figure 1. Example of PWM output mode

The following waveform gives the example of PWM output mode and the effect of the delay:

Workaround

Set the compare value to the desired value minus 1. For instance in order to generate a compare match when LPTIM_CNT = 0x08, set the compare value to 0x07.

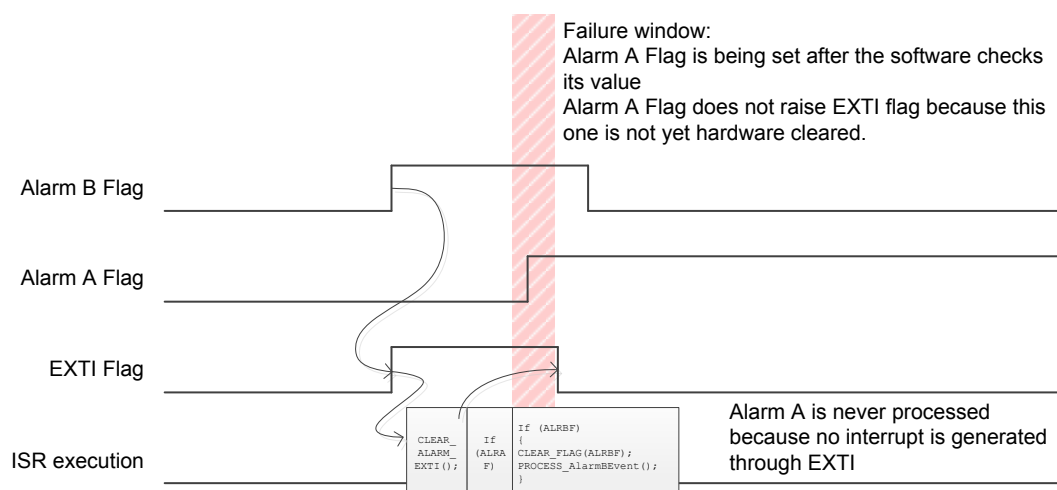
Figure 2. Masked RTC interrupt

The following code example and figure illustrate the failure mechanism: The Alarm A event is lost (fails to generate interrupt) as it occurs in the failure window, that is, after checking the Alarm A event flag but before the effective clear of the EXTI interrupt flag by hardware. The effective clear of the EXTI interrupt flag is delayed with respect to the software instruction to clear it.

Workaround
