STM32H7Rxx/7Sxx device errata

Applicability

This document applies to the part numbers of STM32H7Rxx/7Sxx devices and the device variants as stated in this page. It gives a summary and a description of the device errata, with respect to the device datasheet and reference manual RM0477. Deviation of the real device behavior from the intended device behavior is considered to be a device limitation. Deviation of the description in the reference manual or the datasheet from the intended device behavior is considered to be a documentation erratum. The term “errata” applies both to limitations and documentation errata.

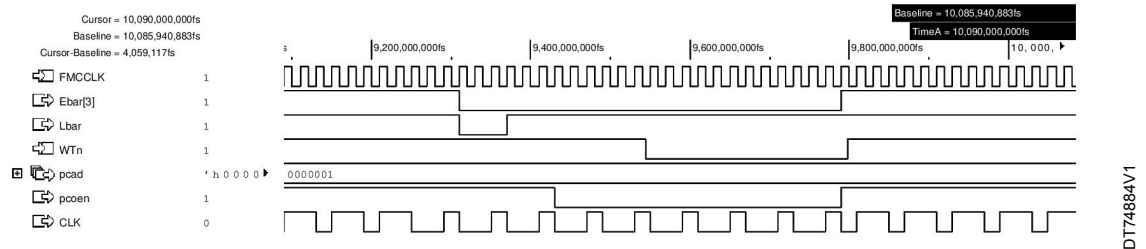
Figure 1. RTL simulation timing diagram

With a clock division of 3 (CLKDIV = 0x02), the FMC continuous clock duty cycle, which is 2/3 high and 1/3 low during read or write transfers, changes to 1/3 high and 2/3 low on the first clock after transfer. The duty cycle change creates a narrow pulse after the data transfer, as illustrated by Figure 1 below.

The narrow pulse after a data transfer is not expected to cause a timing violation for PSRAM, as CLK may be off and irrelevant after the transfer is complete.
