# STM32WB15CC device errata

This document applies to STM32WB15CC devices and the device variants as stated in this page.

It gives a summary and a description of the device errata, with respect to the device datasheet and reference manual RM0473.

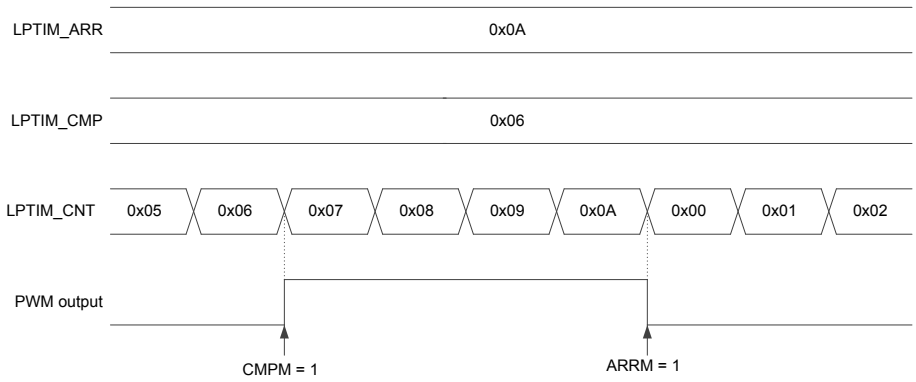
**Figure 1. Example of PWM output mode**

The following waveform gives the example of PWM output mode and the effect of the delay:

Set the compare value to the desired value minus 1. For instance in order to generate a compare match when LPTM_CNT = 0x08, set the compare value to 0x07.

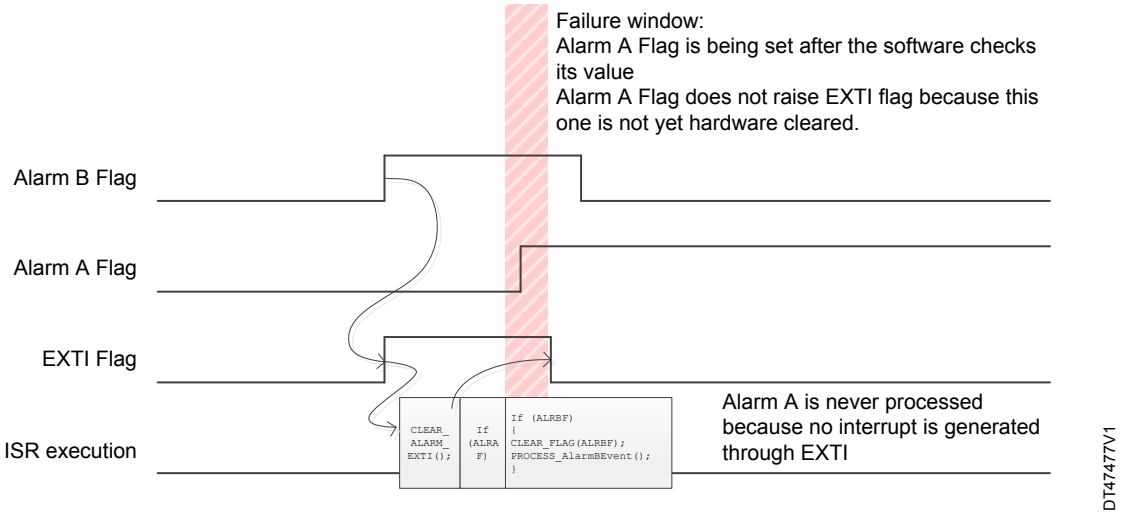
**Figure 2. Masked RTC interrupt**

The following code example and figure illustrate the failure mechanism: The Alarm A event is lost (fails to generate interrupt) as it occurs in the failure window, that is, after checking the Alarm A event flag but before the effective clear of the EXTI interrupt flag by hardware. The effective clear of the EXTI interrupt flag is delayed with respect to the software instruction to clear it.

In the interrupt service routine, apply three consecutive event flag ckecks - source one, source two, and source one again, as in the following code example:
